Manhole Inspection Summary

Manhole # S41A__004MH

Insp Date: **6/26/08 10:15 AM**

Location Address: **500 n caroline st**

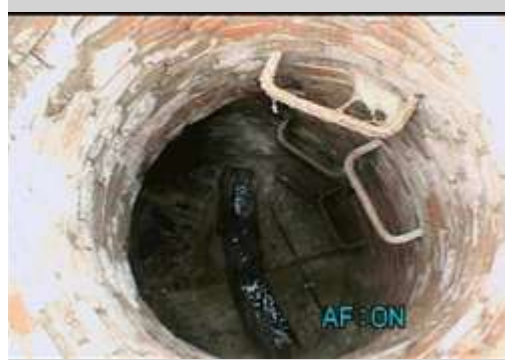
Top View

top view

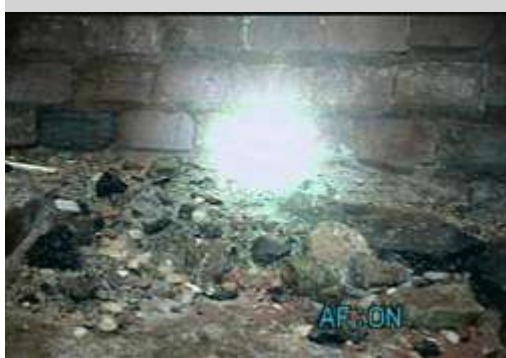
Miscellaneous

bench debris

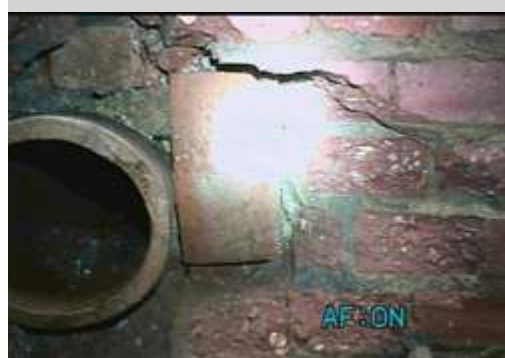
Defect 3

Condition: ☐ Sound ☐ Cracked ☐ Root Intrusion ☒ **Loose Brick** ☒ **Deteriorated**

cracked, missing brick in barrel around break-in

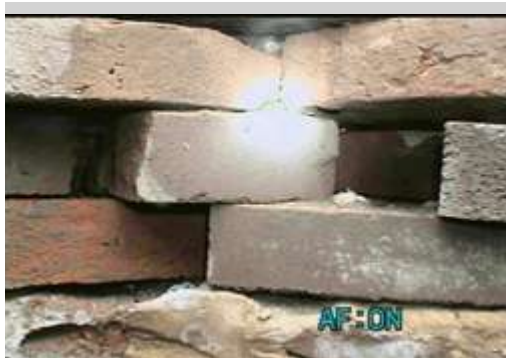
Defect 1

Condition: ☐ Sound ☒ **Cracked** ☐ Root Intrusion ☒ **Loose Brick** ☐ Deteriorated

chimney cracked, loose bricks, frame adj

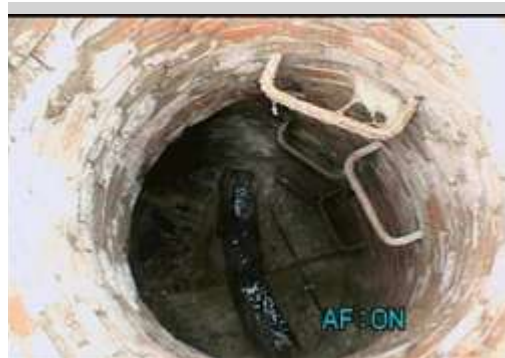
Defect 4

Condition: ☐ Sound ☒ **Cracked** ☐ Root Intrusion ☒ **Loose Brick** ☐ Deteriorated

Count: **5** Missing: **0** ☒ **Corroded**

corbel cracked and loose bricks, corroded steps

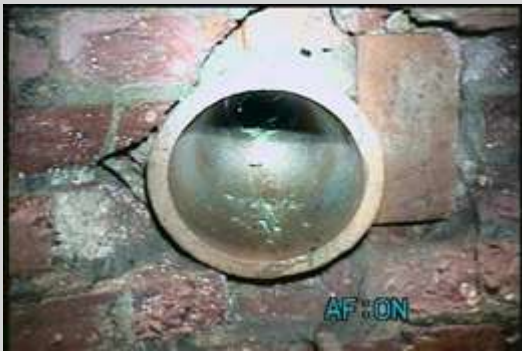
2 O'Clock Inflow

break-in
